From: FIA Single-Seater Department

Date: 20 October 2022

Re: Report on the events involving the deployments of recovery vehicles during the 2022 Japanese Grand Prix (FIA Formula One World Championship)

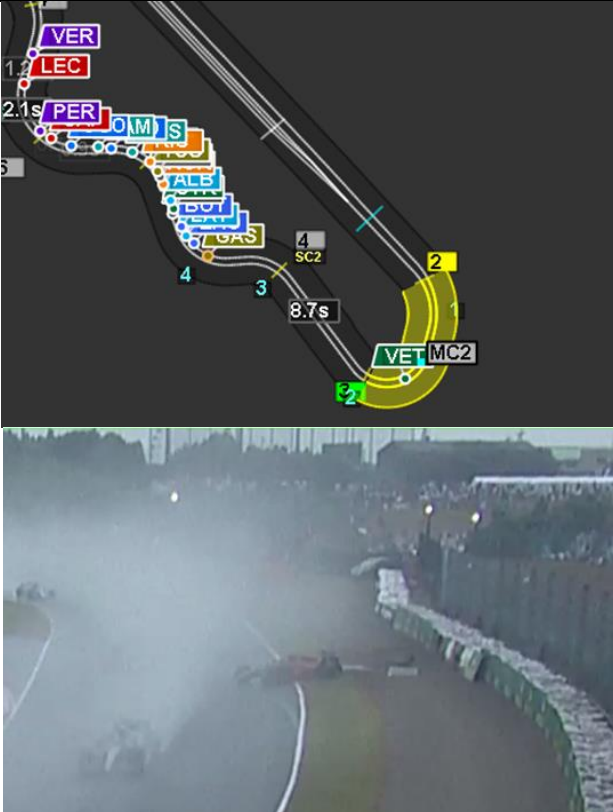
TIMING	EVENTS
14:00:00	Formation Lap
14:03:36	Race Start
<p>14:03:52 Yellow Flag Sector 2 (T2) – Car #5 (VET) Spins following contact with Car #14 (ALO) on entry to Turn 1</p> <p>14:04:12 Clear in Sector 2 (T2)</p> <p>14:04:46 Car #55 (SAI) in WET tyres Sector 12 at T12 entry – “Incident 1”</p>

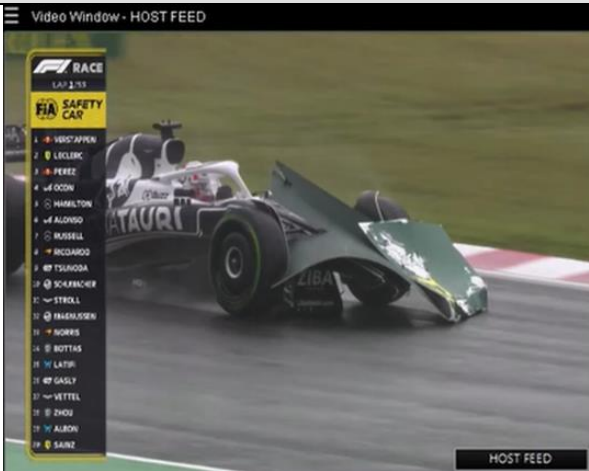
TIMING	EVENTS
<p>14:05:05 Car #10 (GAS) hits advertising boarding and continues around the track with the advertising board wedged on the front of his car.</p>

Assessment of the current application of advertising boards, their construction, location and materials used to avoid the potential for them to being torn off and thrown on track.	2023	FIA & FOM
Improving the visibility of recovery vehicles by adding extra powerful lights (F1 Rain Lights)	2023-24	FIA & FOM
Circuit drainage improvements in Suzuka	TbD	FIA & FOM

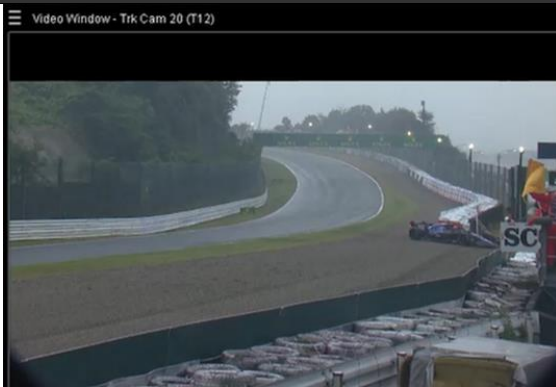
<p>14:05:28 Car #23 (ALB) stops at T12 exit – <i>“Incident 2”</i></p> <p>14:05:59 Marshals attend Car #23 (ALB)</p>

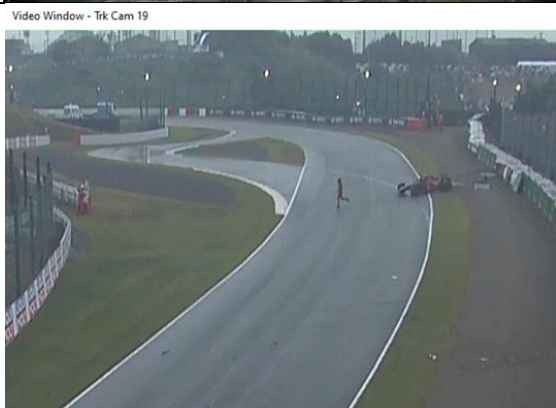
<p>14:06:24 Car #55 (SAI) runs across the track at T12 having received permission from a track marshal.</p>

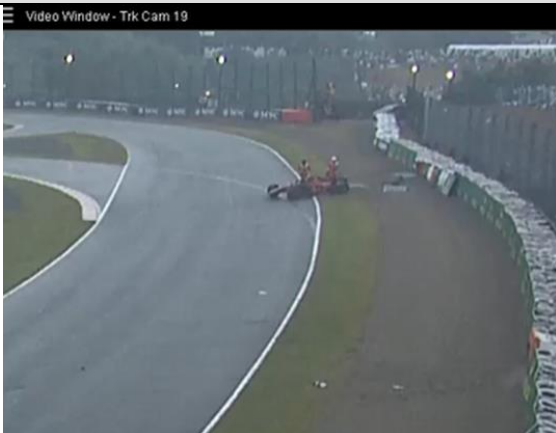
TIMING	EVENTS
<p>14:06:25 Car #11 (GAS) enters the pit lane</p> <p>14:06:32 Marshals enter the track at T12 entry under Clerk of the Course and Race Director Instructions – “Incident 1”</p> <p>14:06:44 Marshals attend Car #55 (SAI) – “Incident 1”</p>

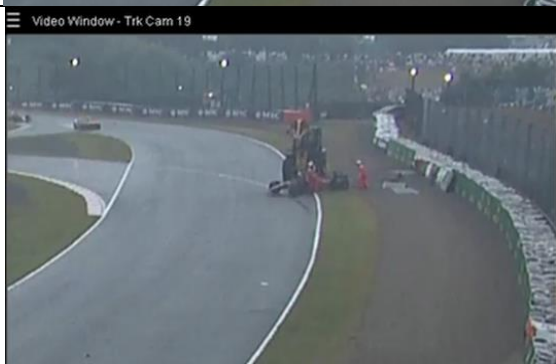
<p>14:06:52 Crane enters the track at T12 entry – “Incident 1”</p> <p>14:07:06 Car #10 (GAS) exits the pit lane</p> <p>14:07:06 Crane enters the track at T12 exit – “Incident 2”</p> <p>14:07:11 Crane attends Car #55 (SAI) – “Incident 1”</p>

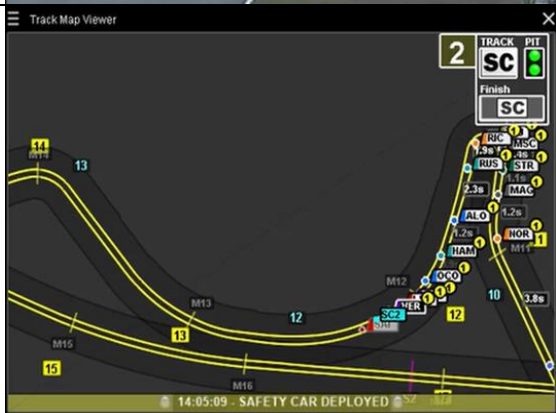
<p>14:07:15 Safety Car and field reach “Incident 1”</p> <p>Speed of the Cars: VER 58 km/h LEC 49 km/h PER 43 km/h OCO 46 km/h HAM 46 km/h ALO 57 km/h RUS 61 km/h RIC 69 km/h TSU 70 km/h MSC 73 km/h STR 78 km/h MAG 70 km/h NOR 81 km/h BOT 92km/h LAT 143 km/h VET 159 km/h ZHO 167km/h</p>

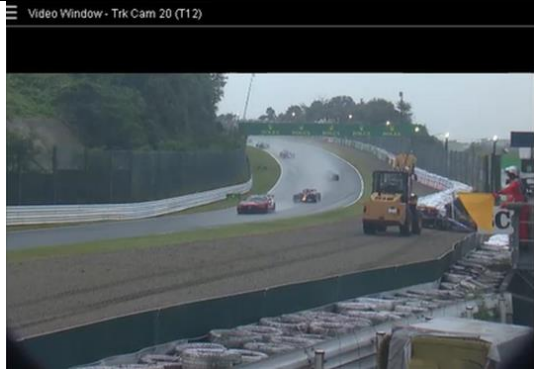
TIMING	EVENTS
<p>14:07:26 Crane attends Car #23 (ALB) – “Incident 2”- As Safety Car and field approach</p> <p><i>Speed of the Cars:</i> VER 86 km/h LEC 99 km/h PER 106 km/h OCO 117 km/h HAM 104 km/h ALO 109 km/h RUS 104 km/h RIC 106 km/h TSU 115 km/h MSC 110 km/h STR 101 km/h MAG 122 km/h NOR 105 km/h BOT 95 km/h LAT 80 km/h VET 85 km/h ZHO 82 km/h</p>

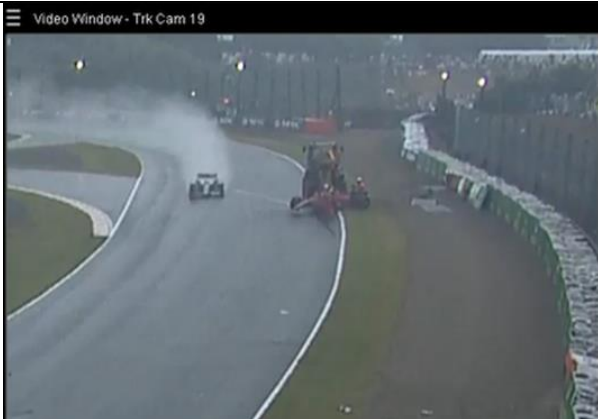
<p>14:08:14 Car #10 (GAS) passes “Incident 1” (189 km/h)</p> <p>Marshals move back out the way</p>

- GAS's speed was at 189km/h on arrival at **Incident 1** (SAI) and 163km/h at **Incident 2** (ALB recovery car) while under red flags. In neither of these two cases were GAS's car speeds compatible with the obligation to slow down and be able to stop his car.

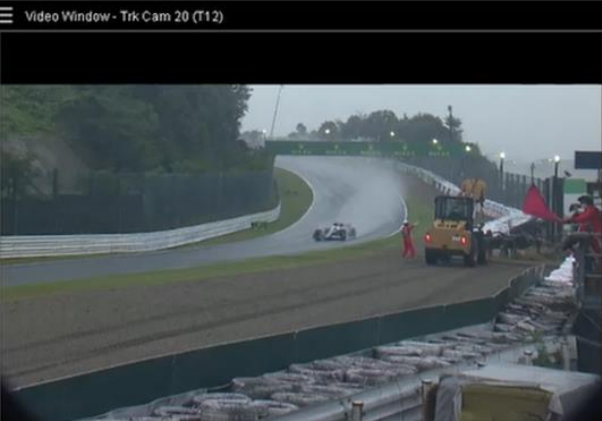
TIMING	EVENTS
<p>14:08:20 Car #10 (GAS) passes "Incident 2" (163 km/h).</p> <p>Car #10 (GAS) then accelerates up to a maximum of 250 km/h for the rest of the lap</p>

- After T12, whilst still under red flags, GAS's car #10 was still reaching speeds of between 200km/h and 250km/h.

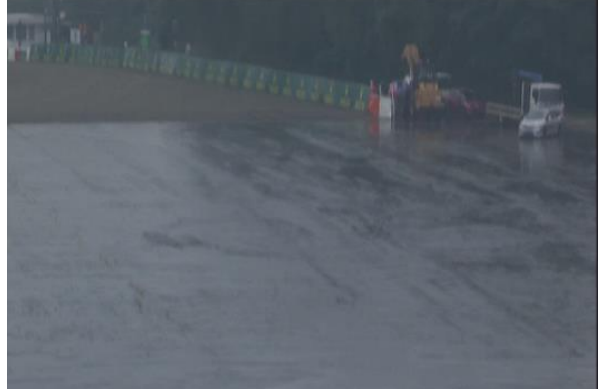
<p>14:11:57 Crane with Car #23 (ALB) exit the track – "Incident 2"</p>
